## ROUGHNESS OF HOLE WALL

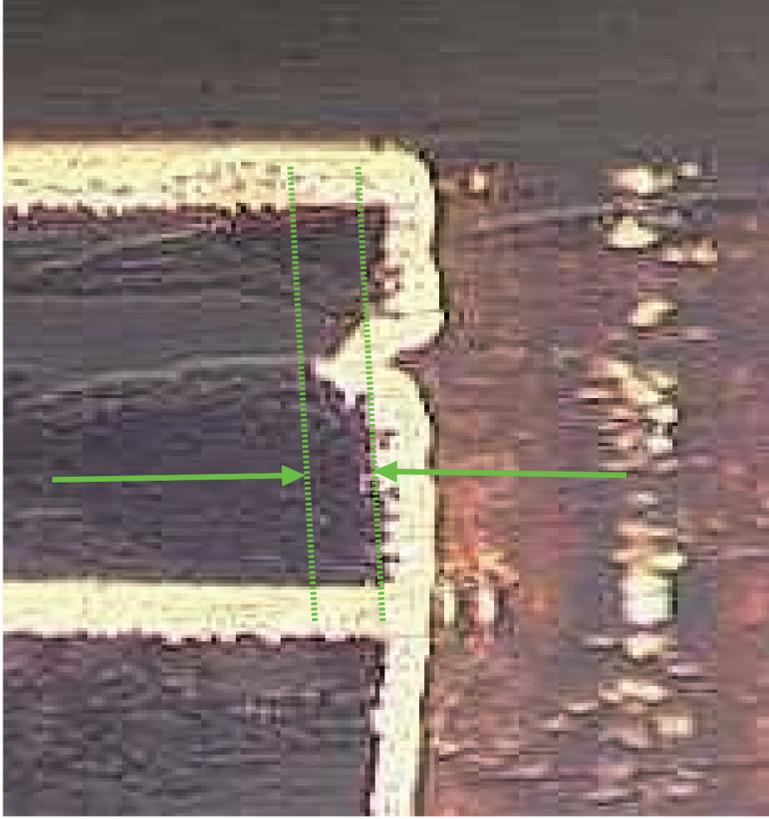
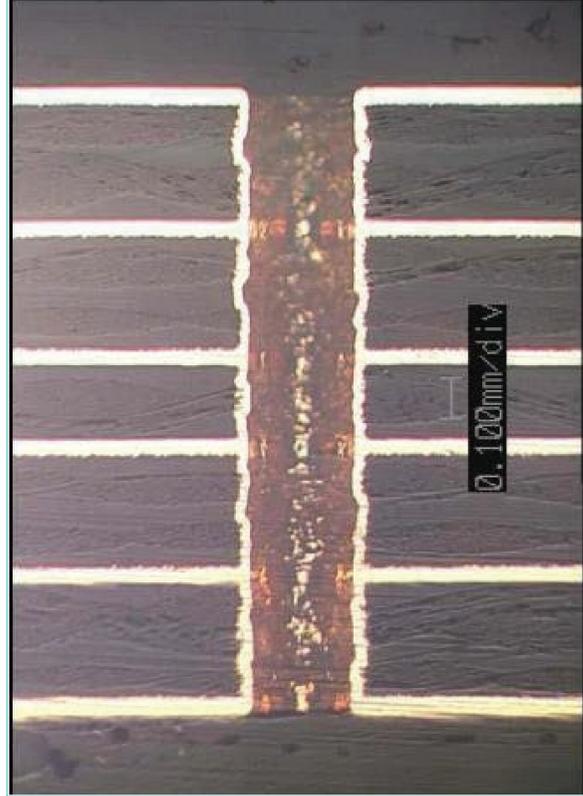
The below pictures shows some very rough holes caused by drilling. This defect should be controlled to get the desired quality requirements.

FAILURE CAUSE	SYMPTOMS	REMEDIES
Use of improper drill geometry	By using low helix drill, the chips do not evacuate smoothly and leads to cause of roughness or By using standard drills	-Use higher helix drills -Use undercut drill
Flute volume too small	Due to this, chips will get clogged in flutes and cause of roughness	Enlarge chip volume in drill geometry
Flute length too short	Due to this, the chips will get clogged in end of flute and cause of rougher finish	Use suitable flute length as per stack height We recommend stack height < 85% of flute length
Thicker margin width	It will increase area of contact to hole wall and raise temperature during drilling which cause the roughness	Keep appropriate margin width
Excessive repointing amount	It will decrease flute volume as well as flute length which cause chip clogging resulting roughness of holes	Control amount of material removal in each grind ( 0.05 to 0.10mm). Set standard for overall length for each re-sharpening.

Carbide material grade	Improper grade of carbide causes more wear and increase hole roughness	Use suitable carbide grade

FAILURE CAUSE	SYMPTOMS	REMEDIES
Improper cutting parameters	Too high chip load or too low chip load causes the hole roughness. Too high chip load will increase chip volume and make hard to evacuate resulting roughness. Also it can damage cutting edge of drill bit and influence hole finish. Low chip load causes slow chip evacuation and more wearing of tool resulting roughness.	Use proper chip loads or optimize cutting parameters as per the drilling set up
Improper peck drilling	If no. of steps and infeed rate do not match the PWB set-up it will affect chip evacuation and cause roughness problem	Recalculate peck drilling steps and cutting parameters
Thick laminates	Chip evacuation is poor due to large volume of chips and causes poor finish	Use lower chip loads or not use more no. of stacks in case of thicker laminates
High Cu content laminates	Spiral copper chips form block chip evacuation as well more wear of cutting edge, resulting poor hole finish	Use lower chip load and decrease stack height Use peck drilling.

Penetration too deep into back-up	Too deep penetration into back-up generate large particle of swarf causing bird nesting.	Use proper back penetration
Improper Stack Preparation	A gap between the entry and boards causes poor evacuation	Do proper stack of entry and laminates, back-up.
Improper vacuum pressure	It affects the chip evacuation and worsens the hole wall	Keep it into recommended limits. It should be > 80mbar in case of micro drilling
Laminates quality	Improper resin and fiber inter-sections leads to poor hole wall quality	Keep control on the laminate quality
Entry material	By using aluminum entry, the fine roughness can not always be expected. The lubricant type entry offers better comparability for fine hole wall conditions.	Use high quality entry board like attached water soluble resin type, multi layer aluminum type etc.

FAILURE CAUSE	SYMPTOMS	REMEDIES
Improper pressure foot	Wider inner dia of bush causes poor evacuation of chips and roughness of holes	Use small inner diameter bush in case of micro drills
Spindle run-out	More spindle run-out causes more wear of cutting edge and drill wandering leads to poor hole wall quality	Keep it into the specified limits. Recommendation is < 0.005mm for micro drills and < 0.012mm for larger diameters >0.50mm
